Warning!

NOT ALL POLY PIPE FITTINGS ARE **PLASSON**.

Product Advice

Product: Plasson® Series 7 Fittings with Black Nuts

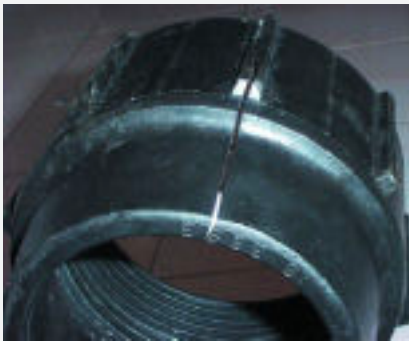
Failed nut with longitudinal split

Non-Plasson fittings differ in dimensions and construction from the Plasson range. These differences cause problems when non-Plasson parts are used in replacements on Plasson bodies. A non-Plasson nut can be applied to a Plasson body, but it is not guaranteed to work to the Plasson standard.

✓ Failures have occurred at various mine sites - split bodies and nuts. Unfortunately, some mine sites have 'reacted' by banning the use of the genuine Plasson fittings. The failures in all the reported cases have been identified as being non-Plasson fittings.

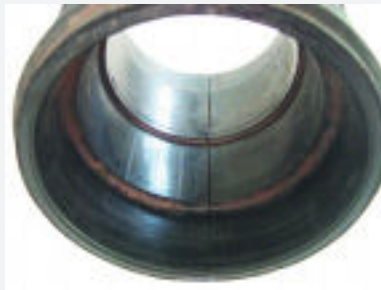
Failed body with longitudinal split

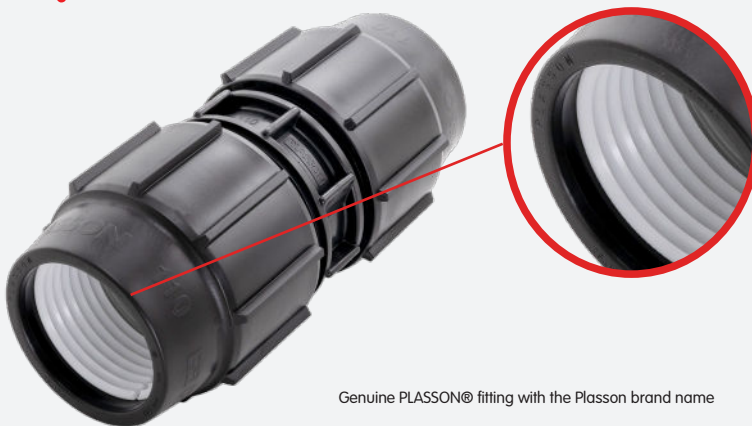
Genuine PLASSON® fitting with the Plasson brand name

Genuine Plasson® fittings have been tried and tested in various environments throughout Australia since 1978 and are the basis for reliable performance in the most demanding and rigorous applications, particularly mining.

- ✓ Specify Plasson® Series 7 Fittings with Black Nuts
- ✓ Ensure Fittings are Branded "Plasson®"
- ✓ Use Plasson® to Plasson® Fittings for Optimum Performance

To ensure quality and reliability in your mining application, specify PLASSON® Series 7 Fittings with Black Nuts.

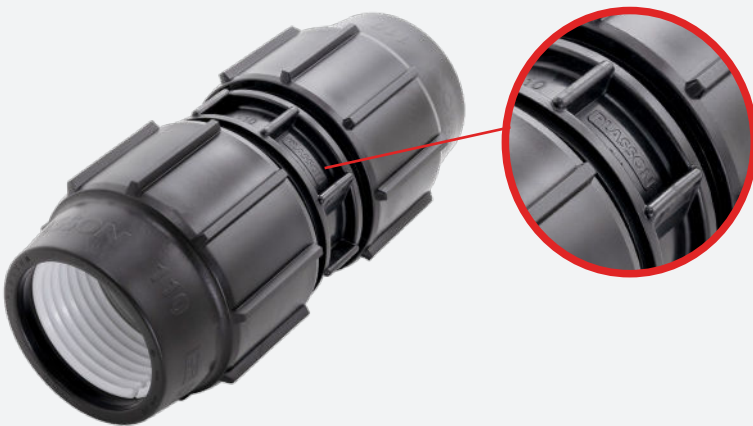
✓ GENUINE PLASSON® FITTING with the Plasson brand name

YOUR SOLUTION IS TO SPECIFY AND ENSURE "PLASSON® SERIES 7 WITH BLACK NUTS" FITTINGS ARE PURCHASED.

CHECK THE BRAND ON ALL FITTINGS AND SPARE PARTS, ENSURE THEY ARE PLASSON®
