Warning!

NOT ALL POLY PIPE FITTINGS ARE PLASSON.

Product Advice

Product: Plasson[®] Series 7 Fittings with Black Nuts

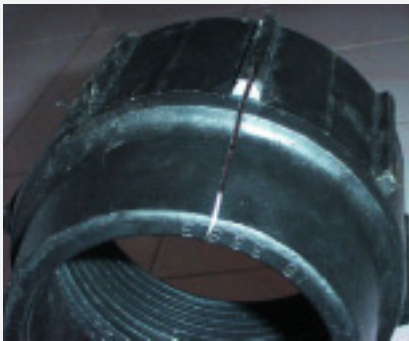
Failed nut with longitudinal split

✓ Failures have occurred at various mine sites - split bodies and nuts. Unfortunately, some mine sites have 'reacted' by banning the use of the genuine Plasson fittings. The failures in all the reported cases have been identified as being non-Plasson fittings.

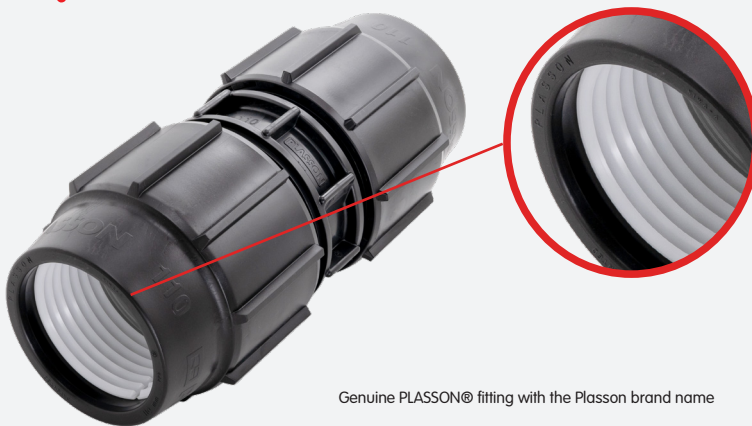
Genuine PLASSON[®] fitting with the Plasson brand name
